Technical Analysis of a Planetary of Gears of an Automobile Differential

^{1*}Joao R. Sartori Moreno, ²Edilson Mathias Junior,
³Émillyn Ferreira Trevisani Olivio

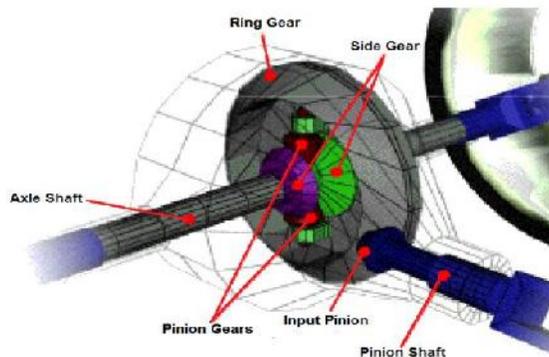
On the other hand in Figure 3 we have the real aspect of the system studied, as this skill required work from our laboratory an important commitment to resolve the

incident that happened exactly in one of the conical pinion gear [2].

Figure 3. Internal components of the gearbox

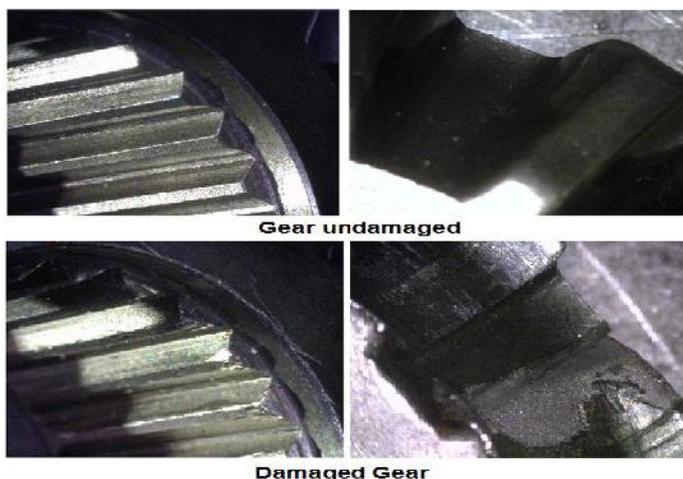
comparatively between the damaged sample and the others [5]. Figure 4 shows a real macrograph of the teeth of the damaged gear and the other undamaged ones. All samples were prepared according to ASTM E3- 11 [6], which requires reference to standardize the grain topography of the samples and better results in the hardness test, which was performed on a Panantec ATMI hardness recorder code 3737.15.

Figure 4. Macrography of damaged and undamaged parts

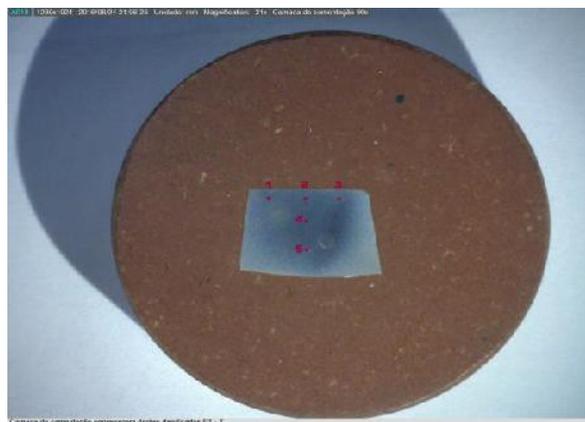
Figure 5. Topography of the measurements from the base metal to the cemented layer of the undamaged specimen.

The Table 1 shows the results of the ring gear support undamaged

Sample of the ring gear support undamaged	
1	867.0
2	929.5
3	797.4
4	838.1
5	867.0
Average	859.8

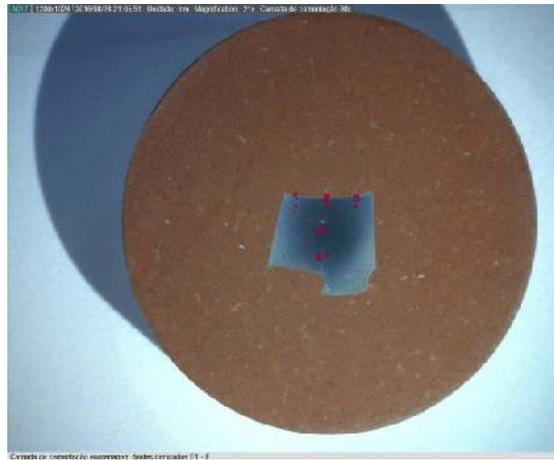
Figure 6. Topography of the measurements from the base metal to the cemented layer of the damaged specimen.

The Table 2 shows the results of the ring gear support damaged

Sample of the ring gear support damaged	
1	312,1
2	321,9
3	321,9
4	305,8
5	277,0
Average	307,7

In this paper along from the measurements of hardness and revealing of the carburizing layer, we can conclude that the damaged gear did not present the same hardness as the gear with differences from 266 HV0.1 to 859.8 HV0.1, that is, with a load of 100 g. However, the damaged gear did not show the occurrence of an apparent carburizing layer, which justifies the hardness of the region where the carburizing layer should have been below of 500/900 HV0.1. Also, the damaged gear showed fractures with accumulation of material that remained in contact during the rotation of the same, because the fact of presenting low hardness in the dentate region, allowed the intense deformation. Therefore, we can conclude that the intensely deformed and fractured gear may not have been thermally treated and improperly mounted in the respective planetary of this differential studied.

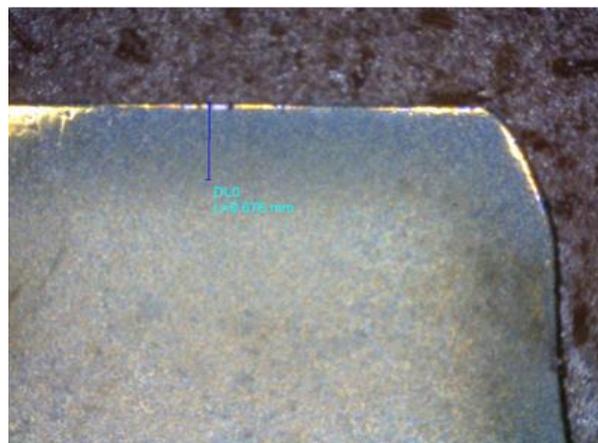
Figure 7 - Thickness of the cementation layer on the undamaged tooth

In Figure 7, we observed that in the top section of the teeth, the cemented layer had an average thickness of 0.676 mm, sufficient to resist transmission wear.
