## **Anthropogenic Interventions and Consequences in Manjra River: Empirical Observations near Village Dighol, Ahmednagar District, Maharashtra, India**

**Dr. Mahadeo Shridhar Jadhav**

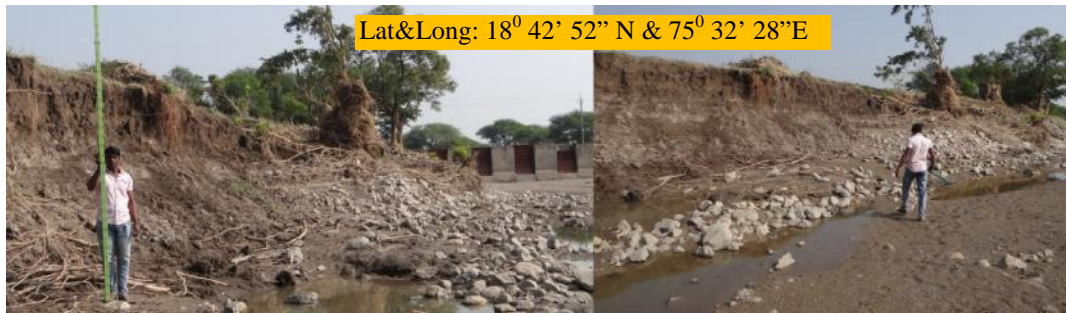
**2. Bank Erosion:** The measurement of river bank erosion and lateral channel change (Lawler 1993) is becoming serious problem of study as human interventions have been increased. All four stretches are witnessed evidences of bank erosion during flood since 2016 (Photo.1). Instability of bank has been increased because illegal practices such as sand mining, well digging, less vegetation, impulsive discharge in monsoon.

**Photo.1** Bank erosion during 2016 Flood near Dighol village in Stretch-3.

The scientific deepening of river channel, increase riparian vegetation, cleaning of river channel, controlling illegal practices such as sand mining and well digging, minimize the flood risk. River restoration treatments are suggested to conserve the river stretches towards water and food security for wellbeing of people in four villages.

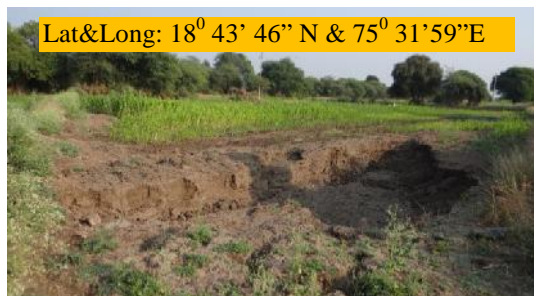
**3. Encroachment &Erosion in Agricultural Land:** Due to encroachment of channel, siltation, less riparian zone and flash flood during monsoon make inundation of agricultural field and

introduced erosion of fertile soil. It is loss of local farmer because losses of soil lead declining in agriculture production (Photo.2).

**Photo.2** Agricultural field erosion

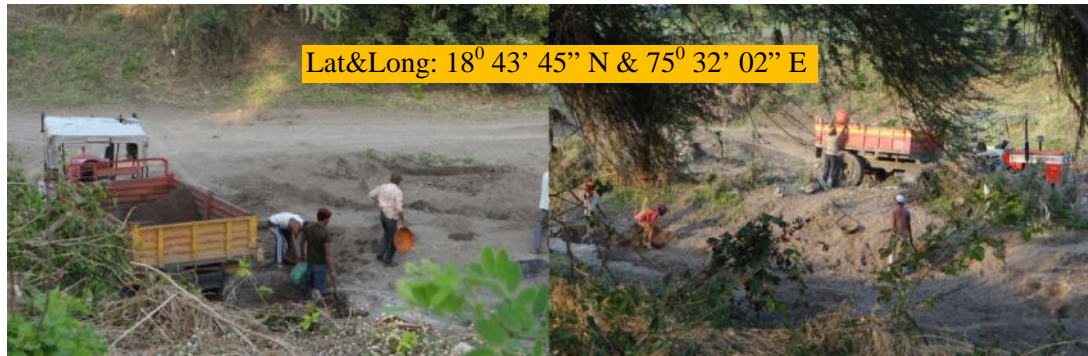
**4. Illegal Sand mining:** In the decade of 1981 to 1990 all stretches under study were full of pure sand. As per Government policy on the sand excavation they introduced sand auction which introduced exploitation of sand and illegal practices. All four stretches have been completely

exploited and today now sand in channel at all. It has been influenced on the underground water level in area (Photo.3).

**Photo. 3** Theft of sand and illegal practice in river channel to exploit Sand

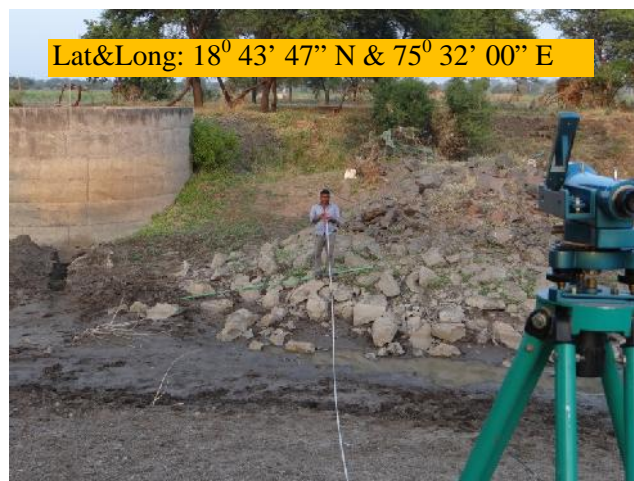
**5. Degradation:** It means lowering of channel bed may occur as a result of structural or climatic changes in association to topography, vegetation and lithology (Leopold, Wolman and Miller 1995), is true to Manjra river stretches but anthropogenic intervention is more dominant than

natural interventions in deepening of river bed. Sand excavations, nonscientific deepening with machines are major human intervention in the degradation of channel bed (Photo 4).

**Plate .4** Degradation of river Manjra

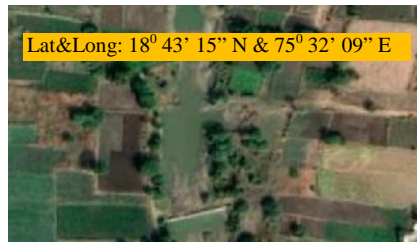
**Plate. 5** Google image of structures

**7. Artificial structure:** There are 11 engineering structures, out of them three are bridges and eight are KT weir. Recently constructed KT weirs are political motivated, hence sites are not appropriate and scientific, hence it increase instability of bank and change in bade morphology of channel.

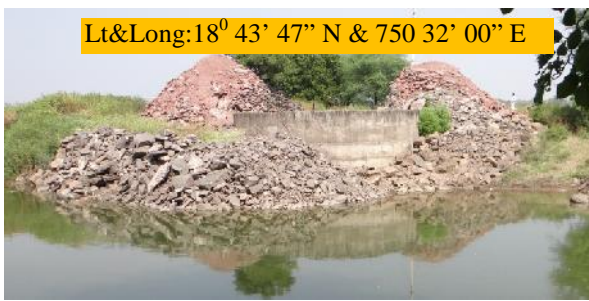
**8. Wells Digging:** The total 92 wells have been observed along and in the chenille. The well distribution in stretches as 37 wells in stretch-1, 07 in stretch-2, 17 in stretch-3 and 31 in strctch-4 respectively.

**Photo 6.** Left bank well & dumped material

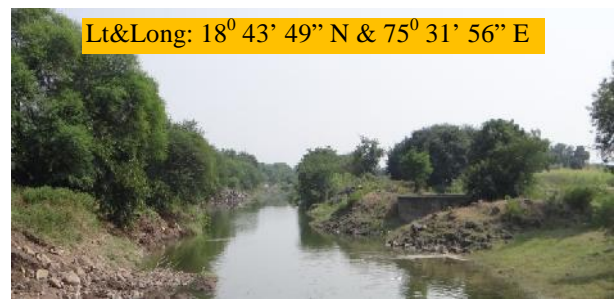
**Photo 7.** Right Bank well & dumped material

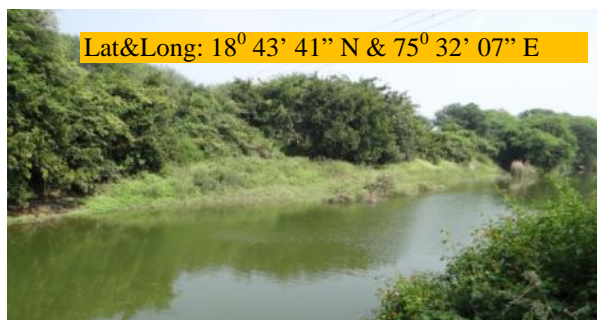
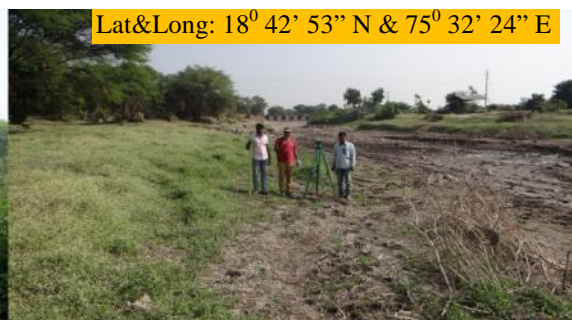
**10. Channel Bars:** As naturally due to degradation and aggradation bars are developed in channel, at few places due to west dumping bars have been developed. But most of bars are developed due to human intervention such as well digging, sand mining and siltation (Photo 8).

**Photo 8.** Channel Bars in the river Manjra in Stretch-3.

Vegetation growth is very serious issue in study area because it increases the flood condition though discharge is less. Inundation of surrounding area has been increased since last few years. It also becoming cause to instability of river bank and leads bank erosion (Photo-8).
