Bank erosion and its affects on sustainable development: A case study on Dihing river basin, Namsai, Arunachal Pradesh.

Tanmoy Mondal

Assistant Professor, Department of Geography, Arunachal University of Studies¹

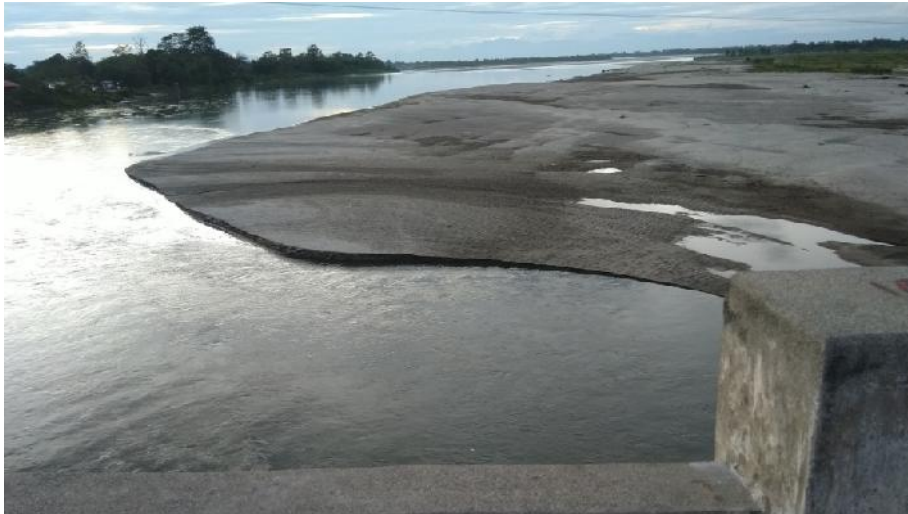
Landslide is a natural phenomenon in Arunachal Pradesh. In the upper course of the Dihing River, it is frequently found. It is very common in rainy seasons. Due to heavy rainfall, the loose materials of the hill come into the river directly by surface runoff and the river water brings this material and deposited it in the middle and lower portion of the river course. Actually, Namsai is situated at the middle course of the Dihing River. So the silted material deposited along the Dihing River between Namsai and Mahadevpur circle which creating problems during the rainy season.

This silted material reduced the depth of the river so during the rainy season when extra water is added to the river then the extra water flooded

*Fig No: 4. Silt Deposition in Dihing River channel between Mahadevpur and Namsai Circle.
Source: Self Click*

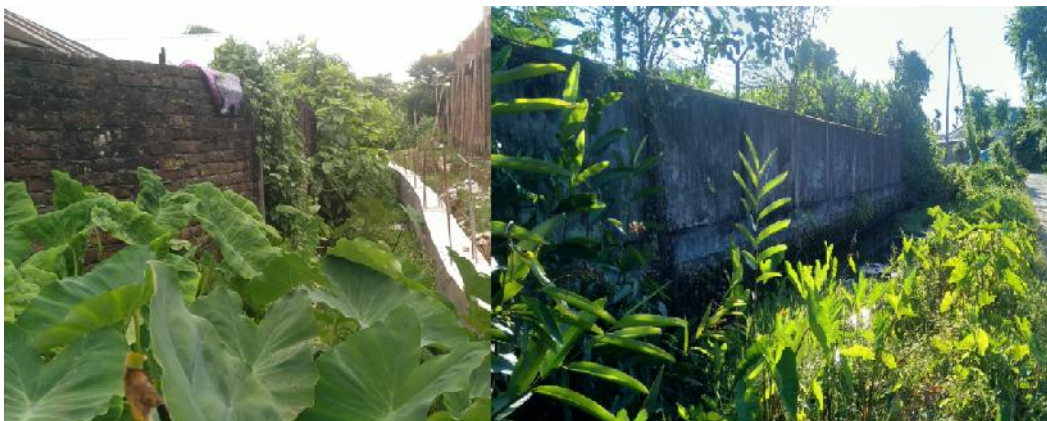
system becomes blocked and in some cases, it totally disappears. In an area where the drainage system is not cleared or blocked there such a type of problem arises during the rainy season. It's happened due to the addition of huge silted materials and the waste materials of the basin area.

Fig No: 7. Block drain in Namsai Circle. Source: Shelf Click

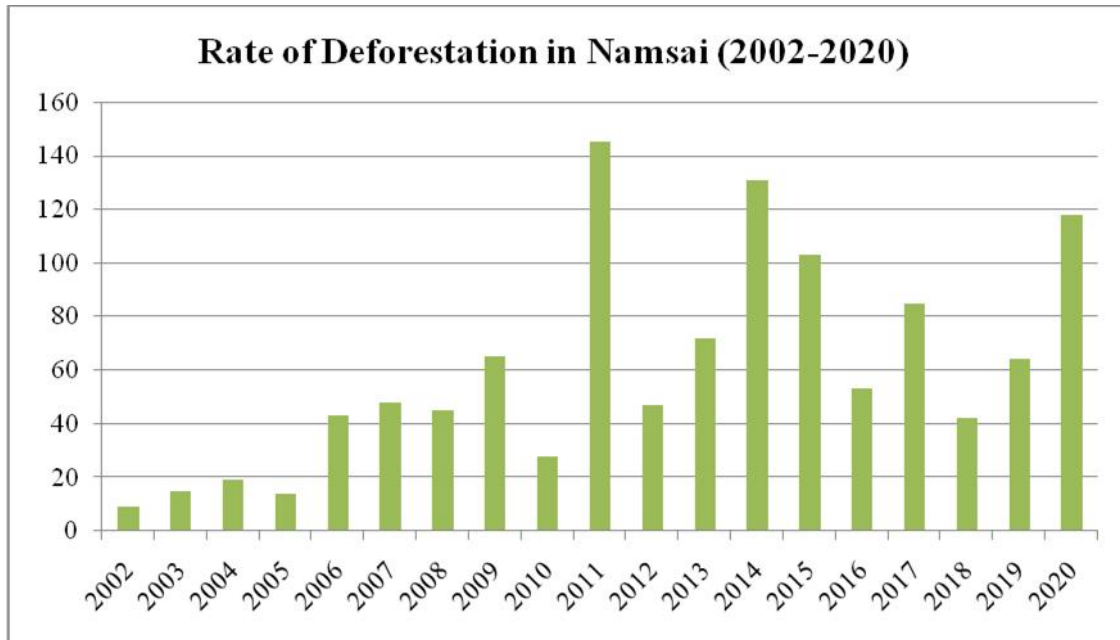
of the river. In the case of Namsai region there the forest area decreases day by day due to the unscientific growth of the urban area. In the year 2002 to 2020, Namsai lost 37% of the forest cover area. So there the soil erosion is increases during the rainy season. If we see that the kharibari area of Namsai circle including Deobill area there is no big tree, so soil erosion, rill erosion, and gully erosion is taking place in this region. During the rainy season, this process is accelerated by rainwater. So when rainwater is added with the Dihing River then the flood takes place in Namsai and Mahadevpur Circle.

Fig No: 8. Bar Graph Showing Rate of Deforestation in Namsai.
 Source: globalforestwatch.org

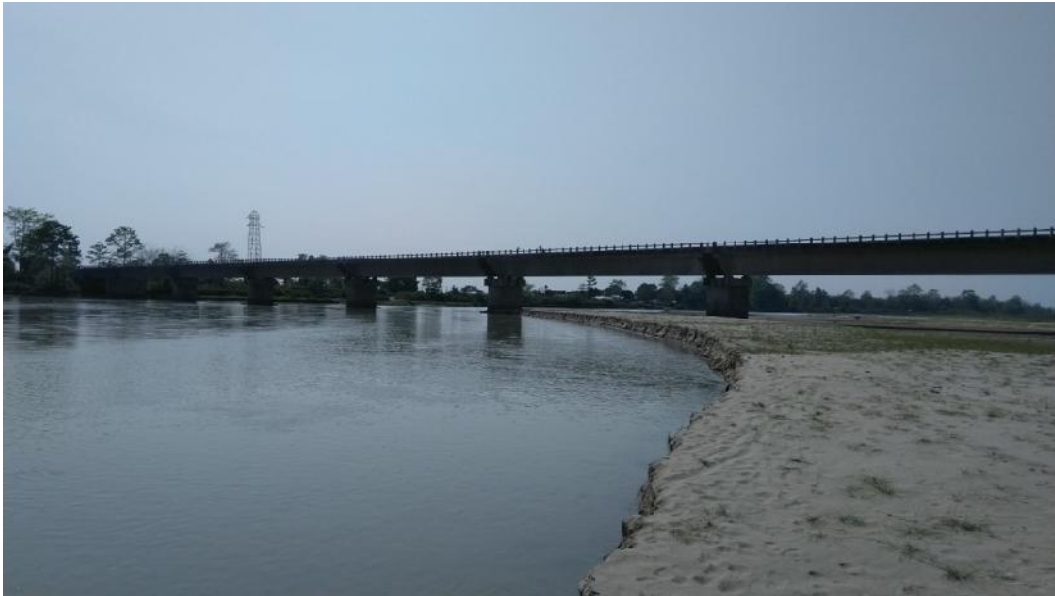
After the built Banka bridge on Dihing River silt deposition are increased between Namsai and Mahadevpur circle, for this reason, there is formed a small island which is submerged during the rainy season. So for this island, the river changes its direction and eroded the agricultural land settlement area of Namsai circle.

*Fig No: 9. Showing Bank bridge connected between Namsai and Mahadevpur.
Source: Shelf Click*

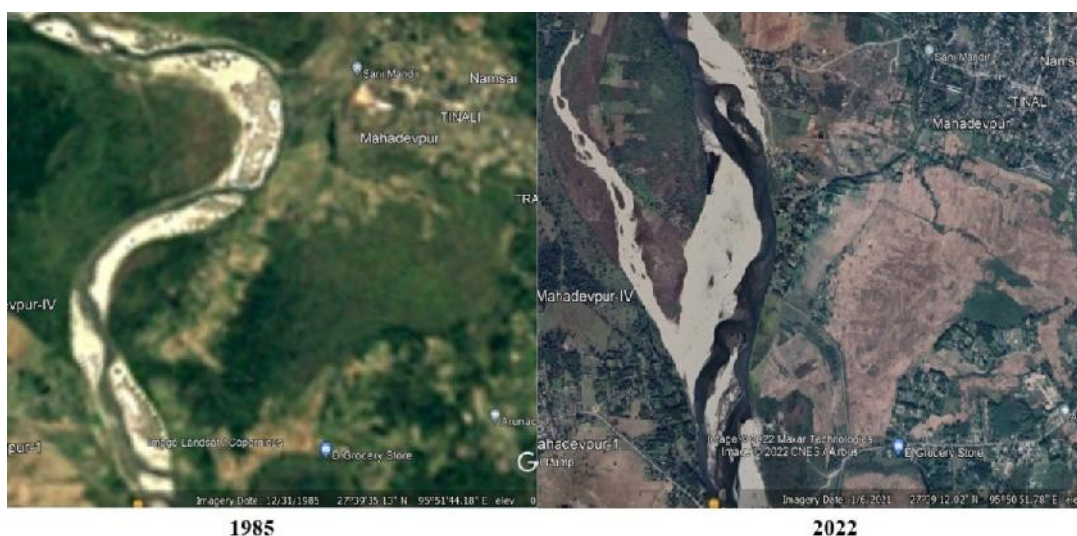
In Namsai due to human influence the forest area is reduced slowly. So soil erosion increases during rainy season. Due to deforestation in Namsai beside the Dihing river basin the erosion increases rapidly. From 2002 to 2020, Namsai lost the 37% forest area. So the bank erosion increases in Namsai and Mahadevpur circle.

Fig No: 10. Satellite image of Dihing River which showing deforestation area in Namsai Circle. Source: Google Earth.

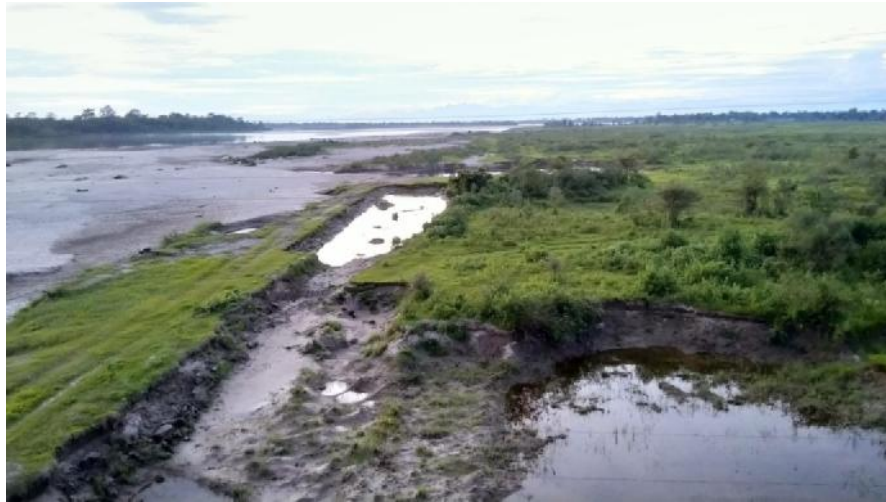
Soil erosion is another cause of the river bank erosion. During rainfall the soil erosion increases in open land and this silted material flows with the water and deposits in the river channel and another cause of soil erosion is irregular soil collecting from river channel.

Fig No: 11. Showing irregular soil collecting form river channel of Dihing in Namsai circle which is the causes of soil erosion. Source: Shelf Click

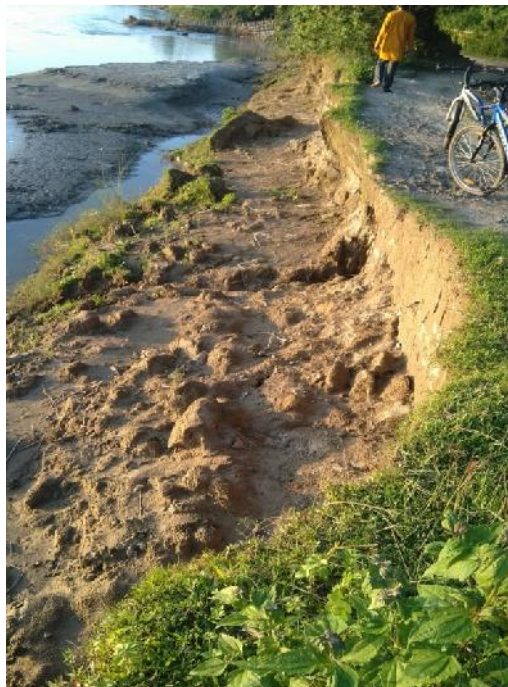
flooded and the road becomes dissolved by water. The direct communication of the people of this area becomes more complicated. On this view we can defiantly say that it is the very common matter at the time of the flood in each year march to August, there are maximum people are basically facing of this problem. As per the report of common people of this area, they also face this same problem during the flood by the riverbank erosion of Dihing. If we see that the road of Kharibari area is very down so during flood due to the lateral erosion of Dihing River it's always submerged.

Image No 13: Showing erosion of road of Kharibari village in Namsai Circle.
